City of Canandaigua Feasibility Analysis for Building Rehabilitation and Re-Use

NEW YORK MAIN STREET TECHNICAL ASSISTANCE PROGRAM

February 9, 2021

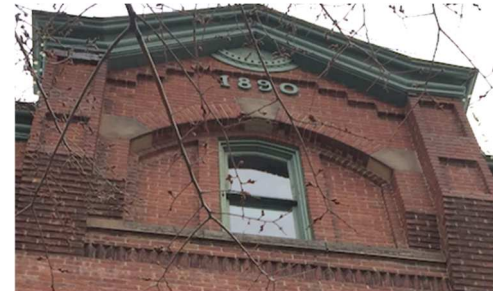
Façade, detail of Cupola

1. Masonry restoration.
2. Replacement of the cupola window to match existing profile and style.
3. Replacement of all 12 windows in the building with energy-efficient, metal clad wood windows to match existing openings and profiles, including the repairs to and replacement of the cupola window.
4. Replacement of existing awning material at commercial spaces.
5. Repairs at bulkhead / stoops.
6. Installation of 3m clear solar film on first floor storefront windows for retailers.

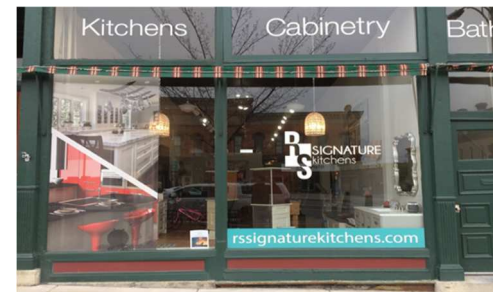
Façade, detail of storefront

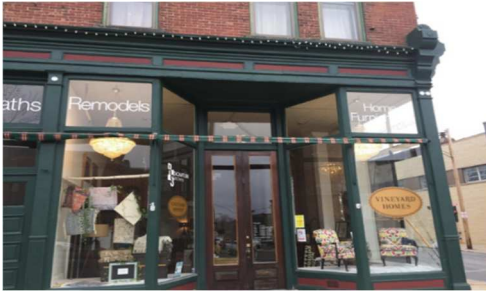
Façade, detail of storefront

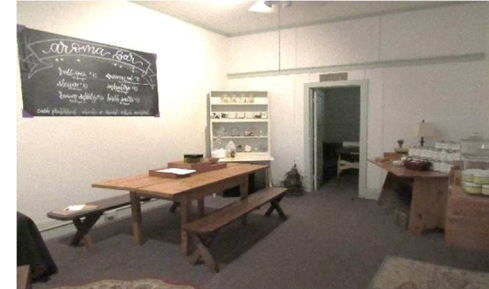
2nd Floor, South Commercial Space

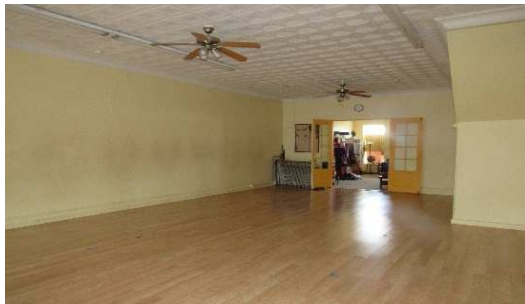
2nd Floor, North Commercial space

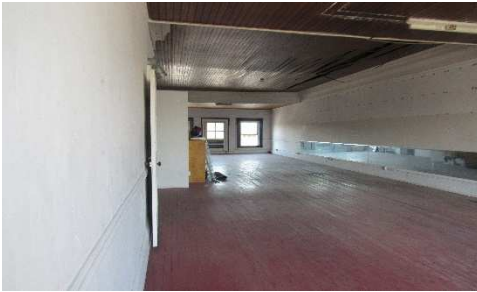
3rd Floor, North unit, looking towards lot

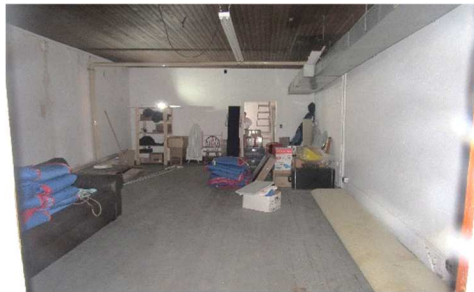
3rd Floor, South unit, middle room

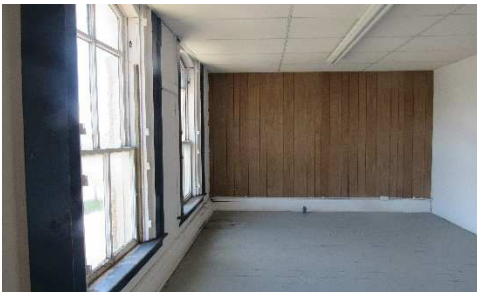
3rd Floor, South unit, overlooking Main St

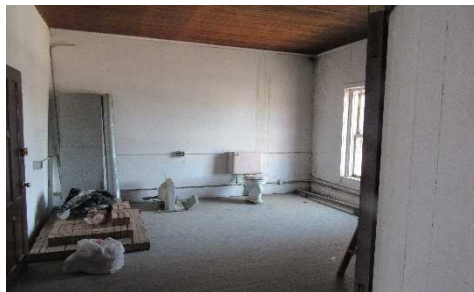
3rd Floor, South unit, looking towards lot

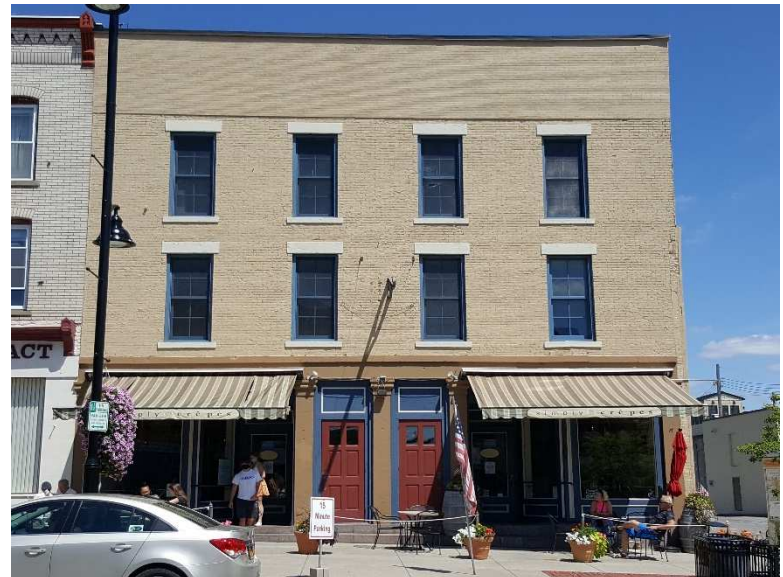
Current view, photo taken August 2020

We recommend a historically appropriate restoration of the S. Main Street façade, including the repair, replacement or restoration of the following elements, as per a previous design:

1. Remove and replace canvas awning material at (2) storefronts
2. Install new metal cornice at front (west) facade compatible in design to historic building.

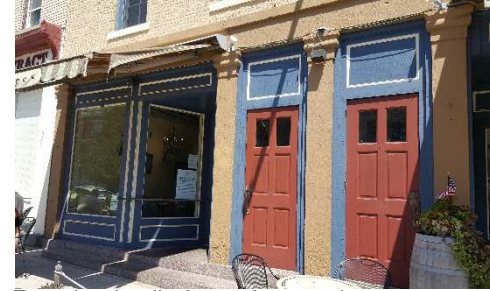
Façade, detail of storefront and entrances

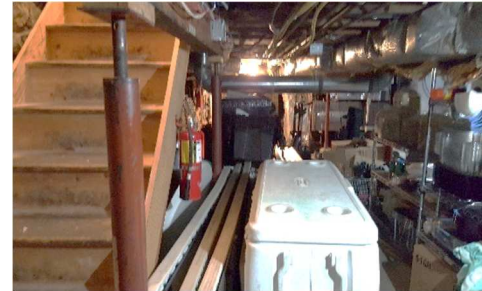
Basement

6. Renovate unfinished basement level to create a rathskeller pub for restaurant: excavate existing dirt floor for new concrete floor; repair and restore existing stone walls, install new door openings and doors; install new fire-rated ceiling while retaining historic wood structure; install new universally accessible toilet room, coat closet and corridor to service stair; install all MEP systems; coordinate installation of bar and fixtures with owner.

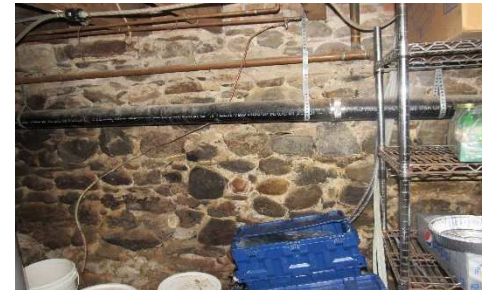
Basement, detail of wall
